Meter Under-Registration caused by Ball Valves in Roof Tanks

Keywords: Meter accuracy, roof tanks, apparent losses.

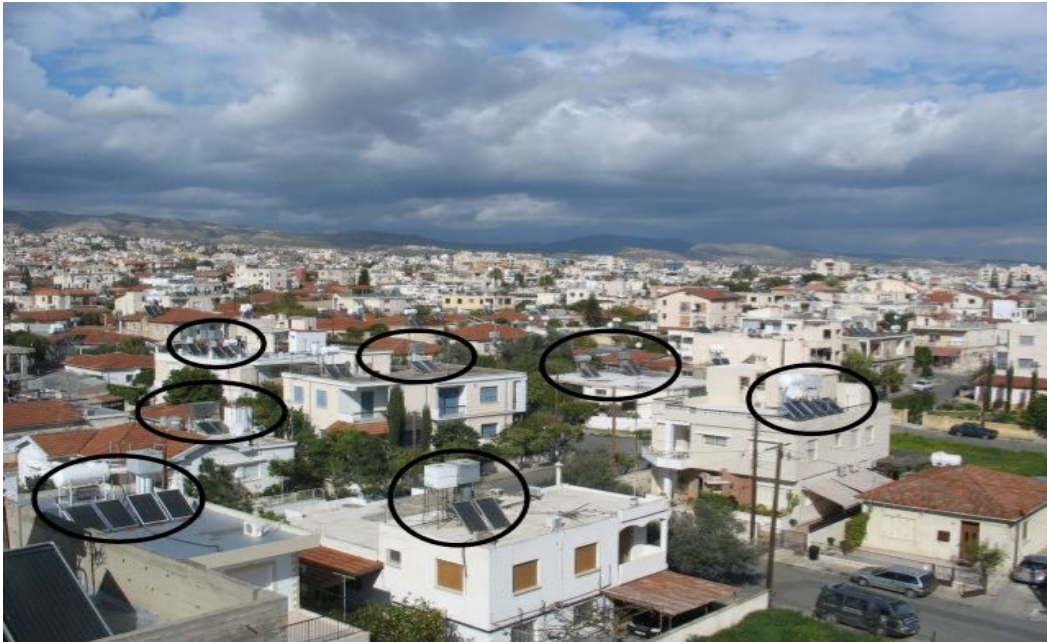
Figure 3. Typical Installation of Domestic Roof Tanks in Houses

In Cyprus and generally in arid and semi-arid regions, where intermittent or unreliable water supplies due to water shortage can occur all households have storage tanks of approximately 1 m³ capacity. In addition advantage is taken of the abundance of sun to provide hot water to the household through the use of solar panels (Figure 3).

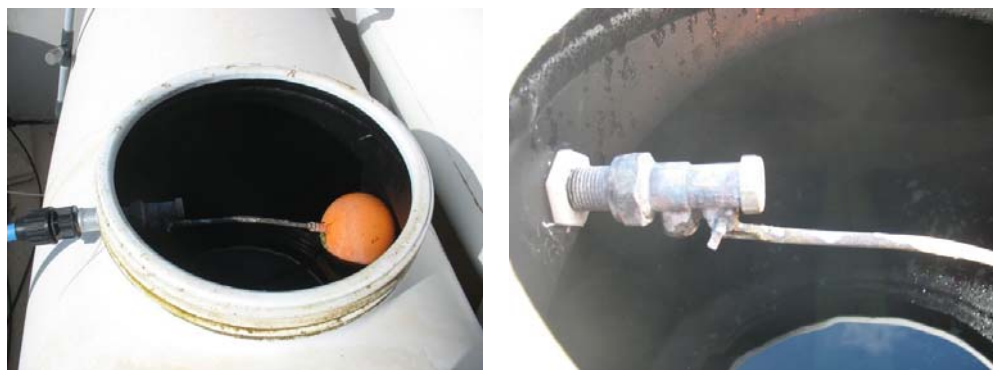
Figure 4. Polypropylene Roof Tank

The galvanized mild steel tanks proved problematic in that they were showing signs of corrosion soon after they were installed and had very limited life span. The galvanized mild steel tanks are no longer produced and are gradually being replaced by polypropylene tanks (Figure 4).

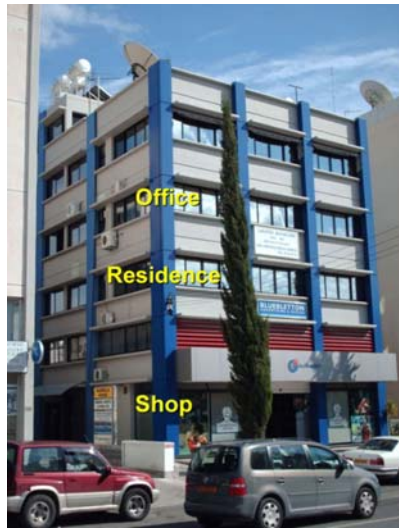
Figure 5. Project site

related to varying degrees of meter under-registration. To this end a Shop, a Residential Flat and an Office all located in the same multi storey building were chosen (Figure 5).

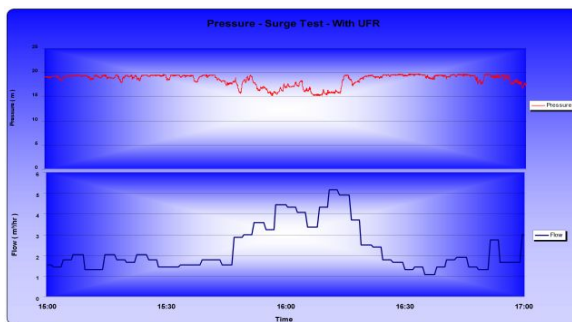
Figure 9. Pressure measurements after installation of UFR

Great emphasis is now placed on minimising surges in distribution systems so it was thought important to have independent pressure measurements on the distribution mains to determine the size (if measurable) and frequency of any surges that may be induced by the UFRs. An appropriate fire hydrant location in the trial zone area was chosen and pressure measurements at 0,1 second intervals were taken before and after the UFRs' installation. Figure 9 shows the measurements after the UFRs were installed and as it can be seen no pressure surges were recorded. Therefore, it can be safely assumed that no surges are induced in the network by the use of the UFRs.

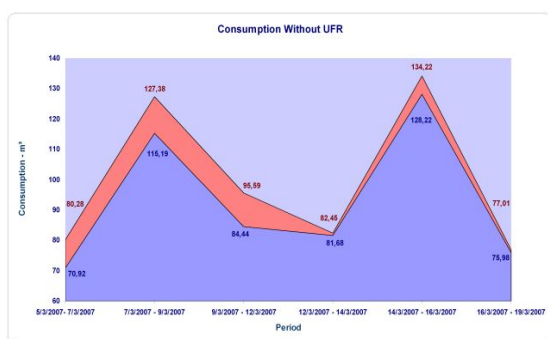
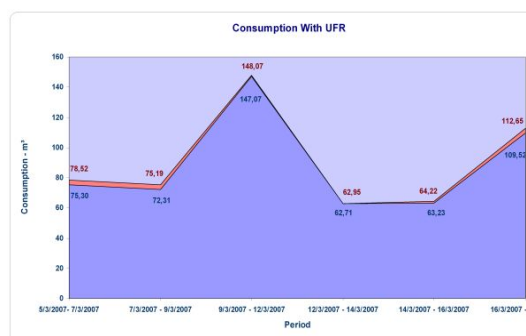
Figure 11. Difference in registered flows without UFR **Figure 12.** Difference in registered flows with UFR

The flows through the main meter were recorded automatically, stored in a programmable controller on site and transferred to a computer in the main Offices of the Water Board at preset times or on request. The domestic meters were manually read three times a week, Monday, Wednesday and Friday, for two consecutive weeks with the UFRs and for another two consecutive weeks without the UFRs. The difference between inflows and outflows without and with UFRs are shown diagrammatically in Figures 11 and 12 respectively. It is evident from the graphs that the difference is a lot less with UFR than without.

The above results are shown in tabular form in Table 2 below. Without the UFRs the meter under-registration was 6,79% whereas with the UFRs this figure was reduced to 2,12%. The use of the UFRs increased the volume of water which was registered by the water meters by 4,67%.
